# Effects of Pedestrian Excitation on Two Short-Span FRP Footbridges in Delft

Stana Živanović<sup>1</sup>, Justin Russell<sup>1</sup>, Marko Pavlović<sup>2</sup>, Xiaojun Wei<sup>1</sup>, J. Toby Mottram<sup>1</sup>

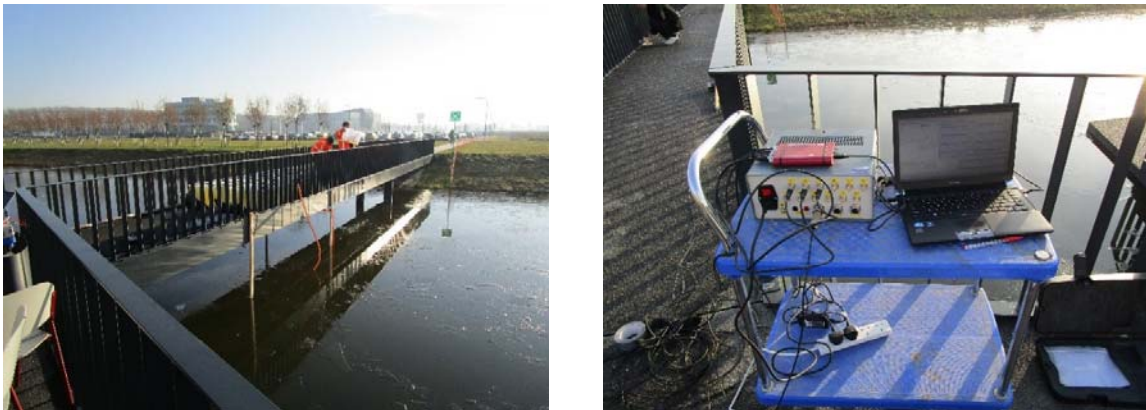
Bridge 1 is a pedestrian bridge at the edge of TU Delft's campus. It consists of two (relatively) independent spans of 15m and 10m with deck width of 2m. Each span has two longitudinal beams made of vacuum infused FRPs with foam cores connected by an FRP deck, moulded as one piece, and resting on neoprene pads at the ends of each span. Surface is an epoxy layer with embedded gravel. Handrails are made of steel and they are continuous along the spans. Total mass of superstructure for the 15m span is estimated at about 4500kg. View of the two spans, as well as of the data acquisition station, is shown in Fig. 1.

**Fig. 1: Bridge 1 – left: side view and right: data acquisition station**

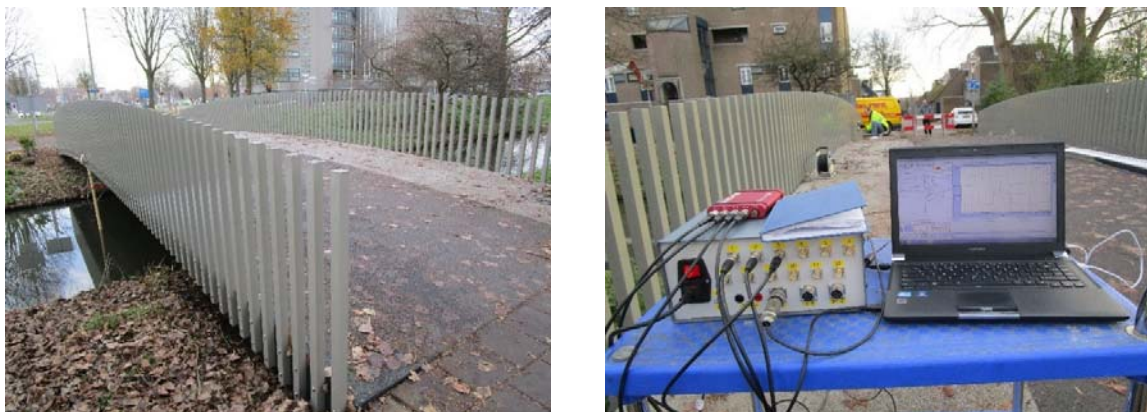
Bridge 2 is a 14.7m long by 4.5m wide pedestrian and cyclist bridge, with allowance for 12 tonne service vehicles. Structure is made of four vacuum infused FRP foam core beams connected by a composite cover. It has a slight camber and sits on concrete supports, with neoprene pads which also restrain it longitudinally. Hand railing is provided by a series of 1m composite posts bolted to side plates. Total mass is 6600kg. Fig 2. shows the bridge and the data acquisition station.

**Fig. 2: Bridge 2 – left: side view and right: data acquisition station**
